Contract #: 04-0120F4Cty: SF/ALA Rte: 80 PM: 13.2/13.9File #: 69.28**WELDING INSPECTION REPORT****Resident Engineer:**Siegenthaler, Peter**Address:** 333 Burma Road**City:** Oakland, CA 94607**Report No:** WIR-018394**Date Inspected:** 17-Nov-2010**Project Name:** SAS Superstructure**OSM Arrival Time:** 700**Prime Contractor:** American Bridge/Fluor Enterprises, a JV**OSM Departure Time:** 1900**Contractor:** Zhenhua Port Machinery Company, Ltd (ZPMC), Changxing Island **Location:** Shanghai, China**CWI Name:** Mr. Li jia**CWI Present:** Yes No**Inspected CWI report:** Yes No N/A**Rod Oven in Use:** Yes No N/A**Electrode to specification:** Yes No N/A**Weld Procedures Followed:** Yes No N/A**Qualified Welders:** Yes No N/A**Verified Joint Fit-up:** Yes No N/A**Approved Drawings:** Yes No N/A**Approved WPS:** Yes No N/A**Delayed / Cancelled:** Yes No N/A**Bridge No:** 34-0006**Component:** Orthotropic Box Girder( OBG)**Summary of Items Observed:**

## WELDING INSPECTION REPORT

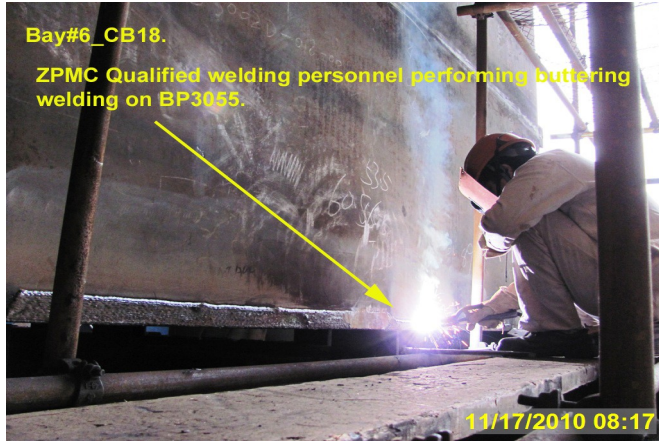
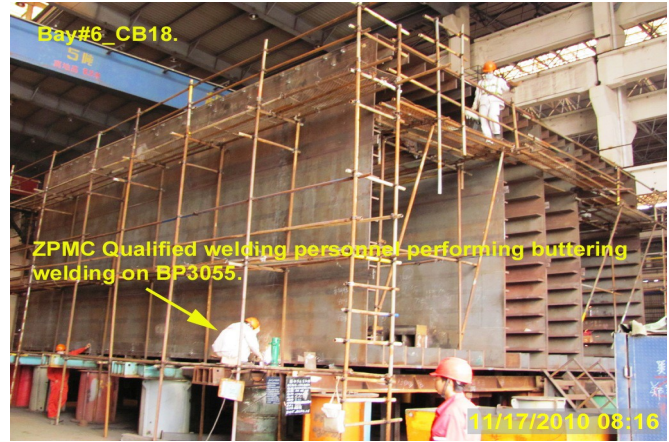
Shielded Metal Arc Welding(SMAW) of weld joint CB3002H-014,015,016. Welder is identified as 054457.

SMAW buttering welding of Cross beam 18 Bottom plate identified as BP3055/PL3290A. Welder is identified as 048659. ZPMC Quality Control (QC) is identified as Mr. Zheng zhi wei. The welding variables appeared to comply with the Applicable WPS: WPS-345-SMAW-2G(2F)-Repair. The buttering welding was being performed as per the Caltrans Engineer approved Critical Welding Repair Report (CWR) No: B-CWR2199.

Refer the attached photos for reference.
